NASA TECHNICAL MEMORANDUM

NASA TM X-58165
October 1975

REFURBISHMENT OF NASA AIRCRAFT
WITH FIRE-RETARDANT MATERIALS

**Daniel E. Supkis
Lyndon B. Johnson Space Center
Houston, Texas 77058**

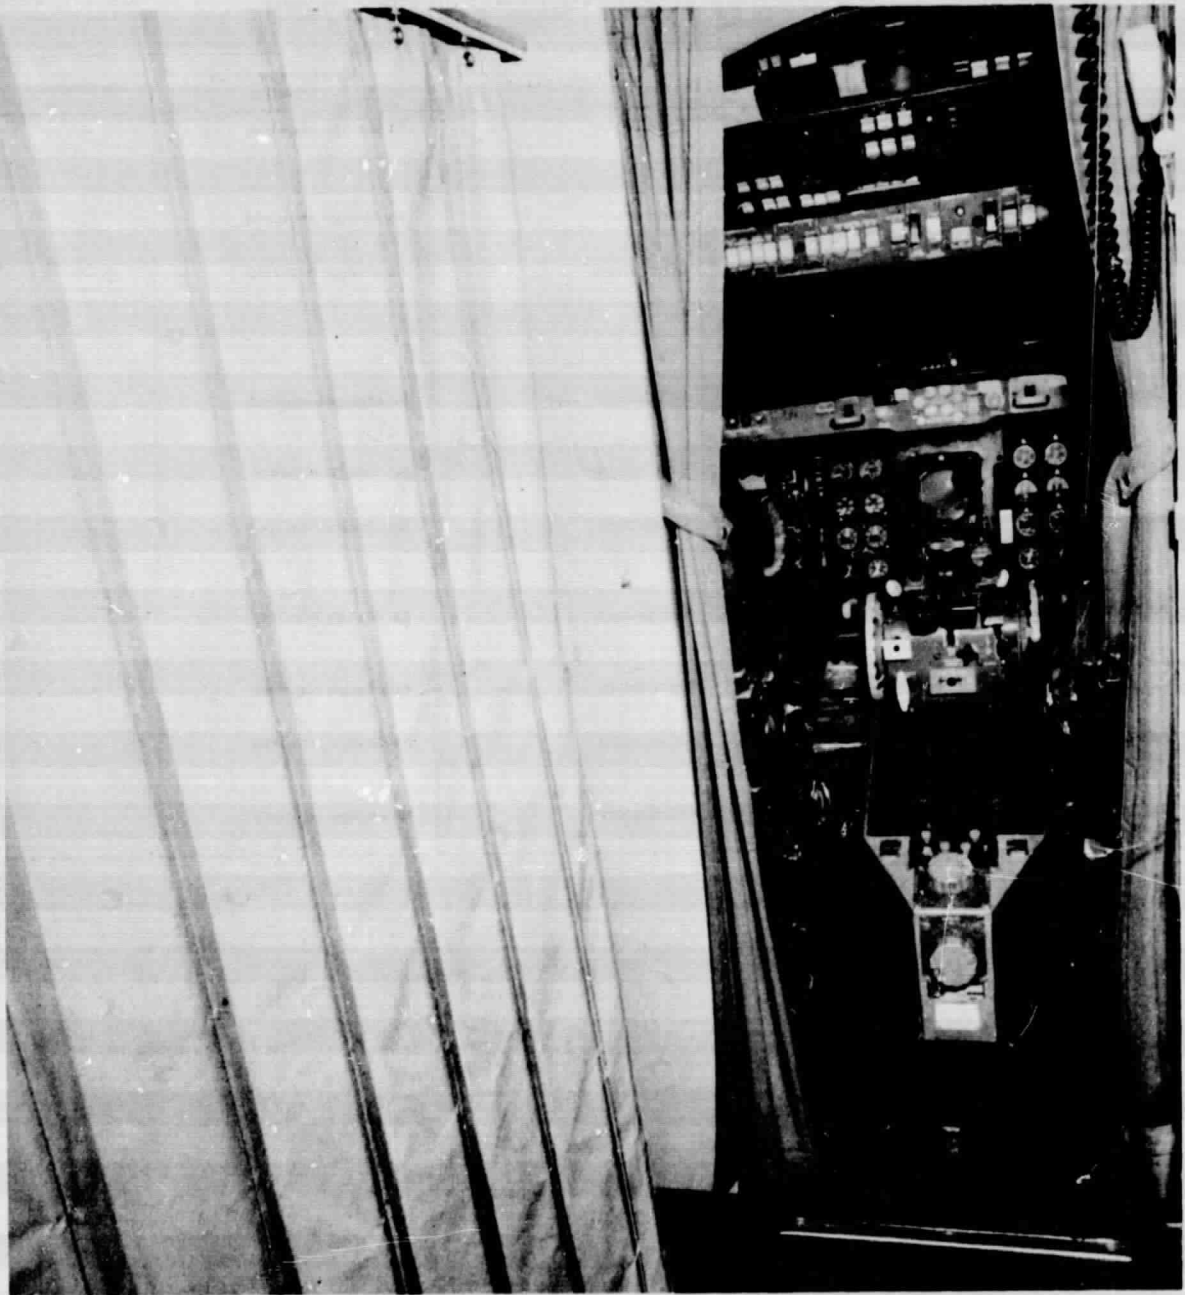
Figure 1.- Gulfstream 2 acoustical entrance drape coating; adhesion failure noted at latch area and at entrance wall edge.

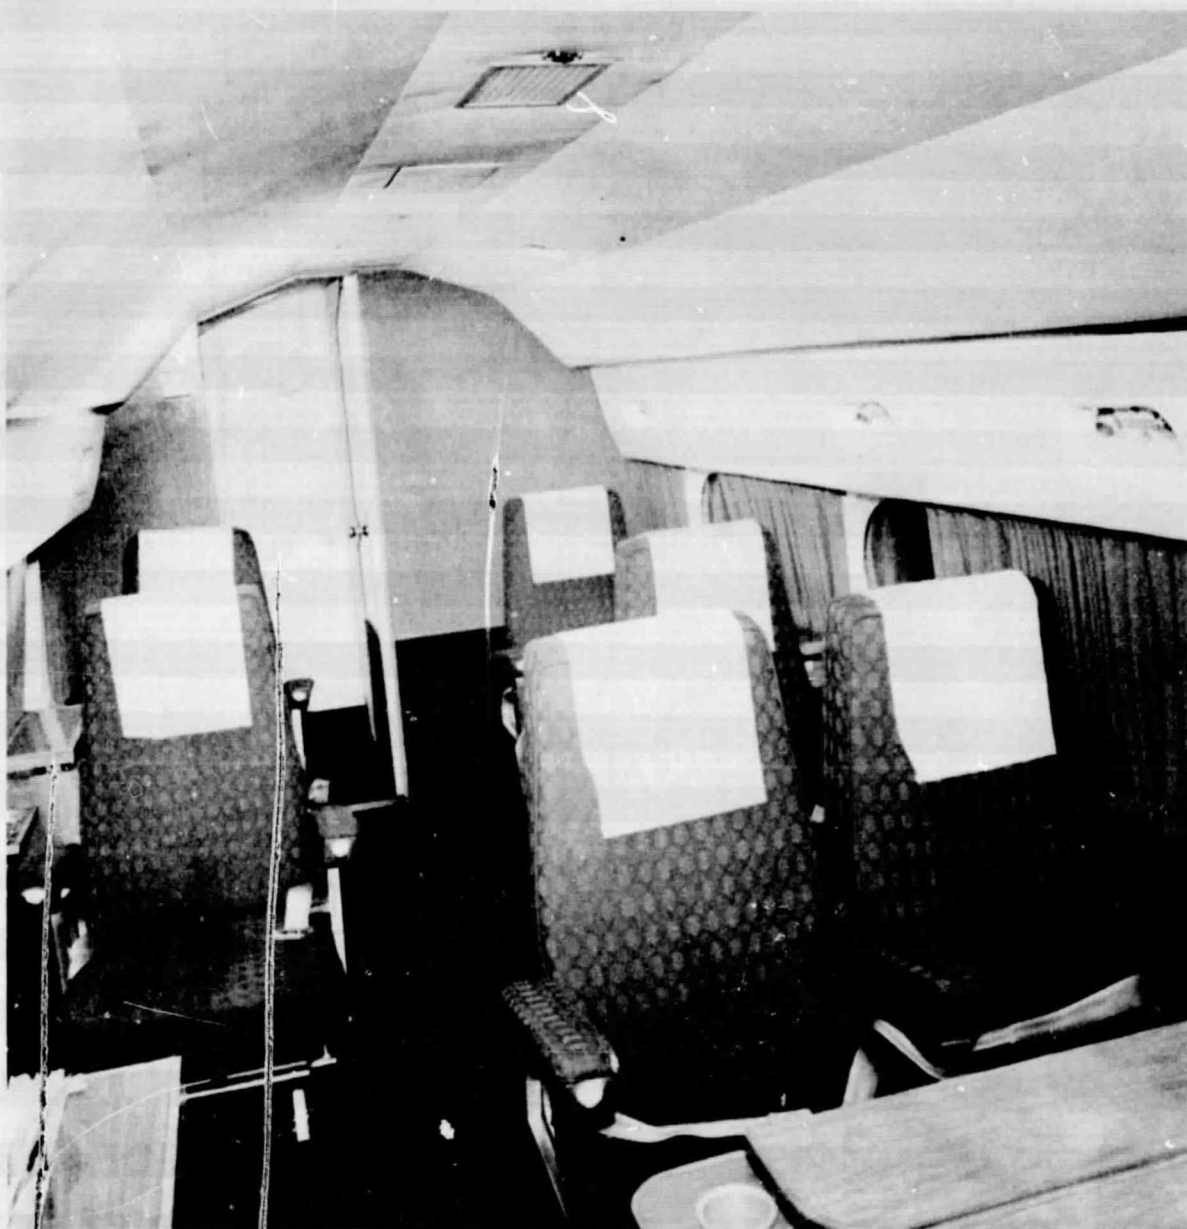
Figure 3.- Gulfstream 2 passenger cabin ceiling, curtains, and side panels in excellent condition after 2 years of service.

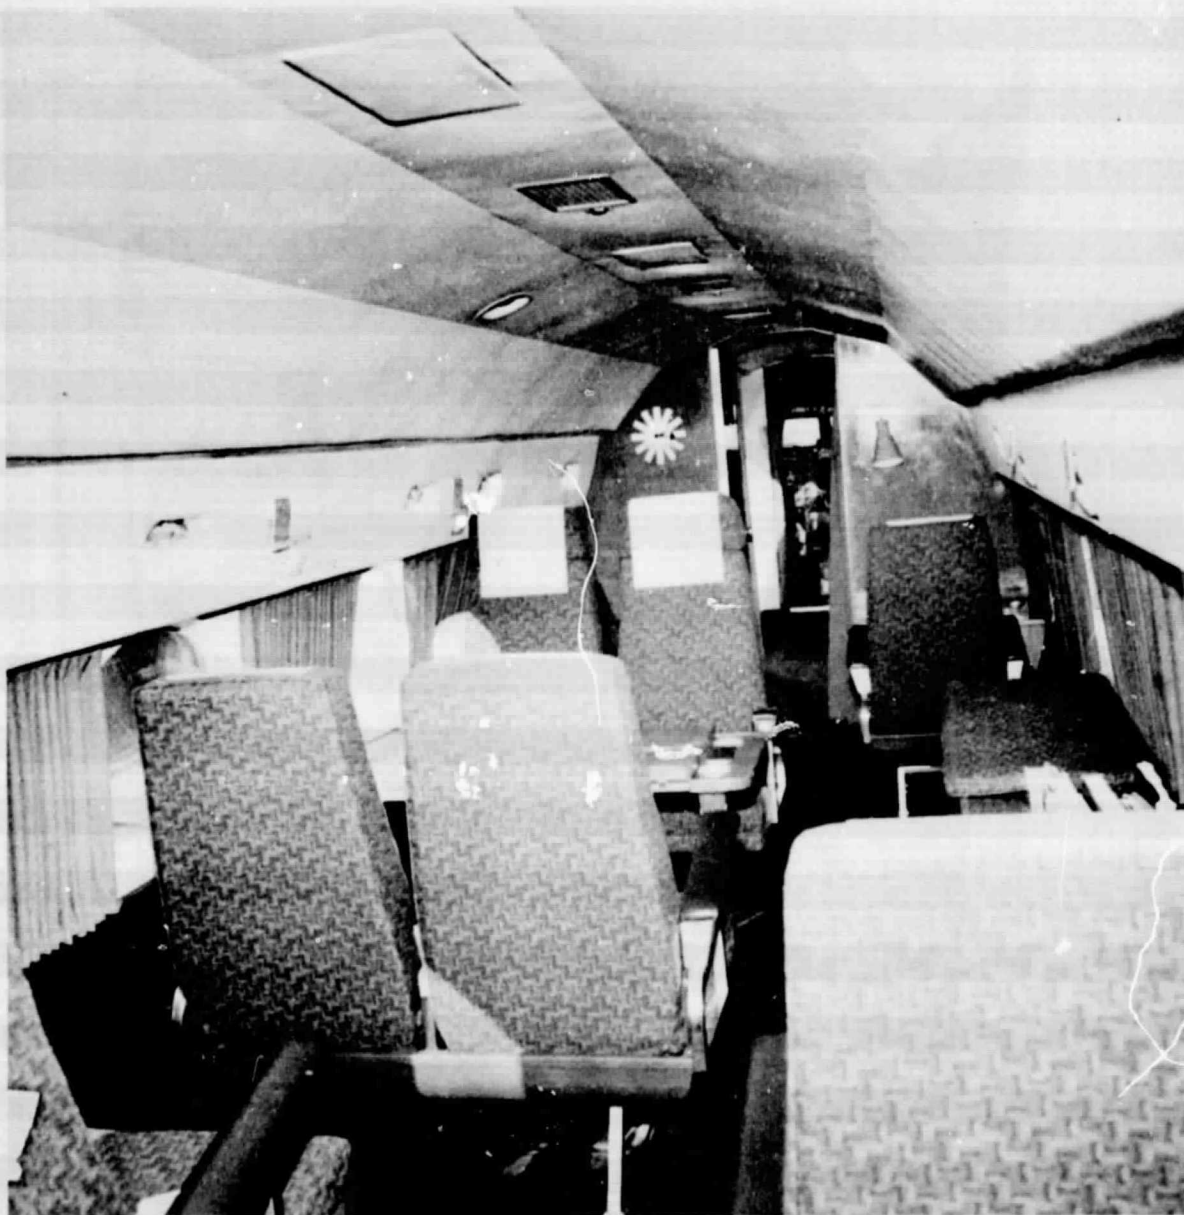
Figure 4.- Gulfstream 2 passenger cabin wool/Leavil-blend seat upholstery.

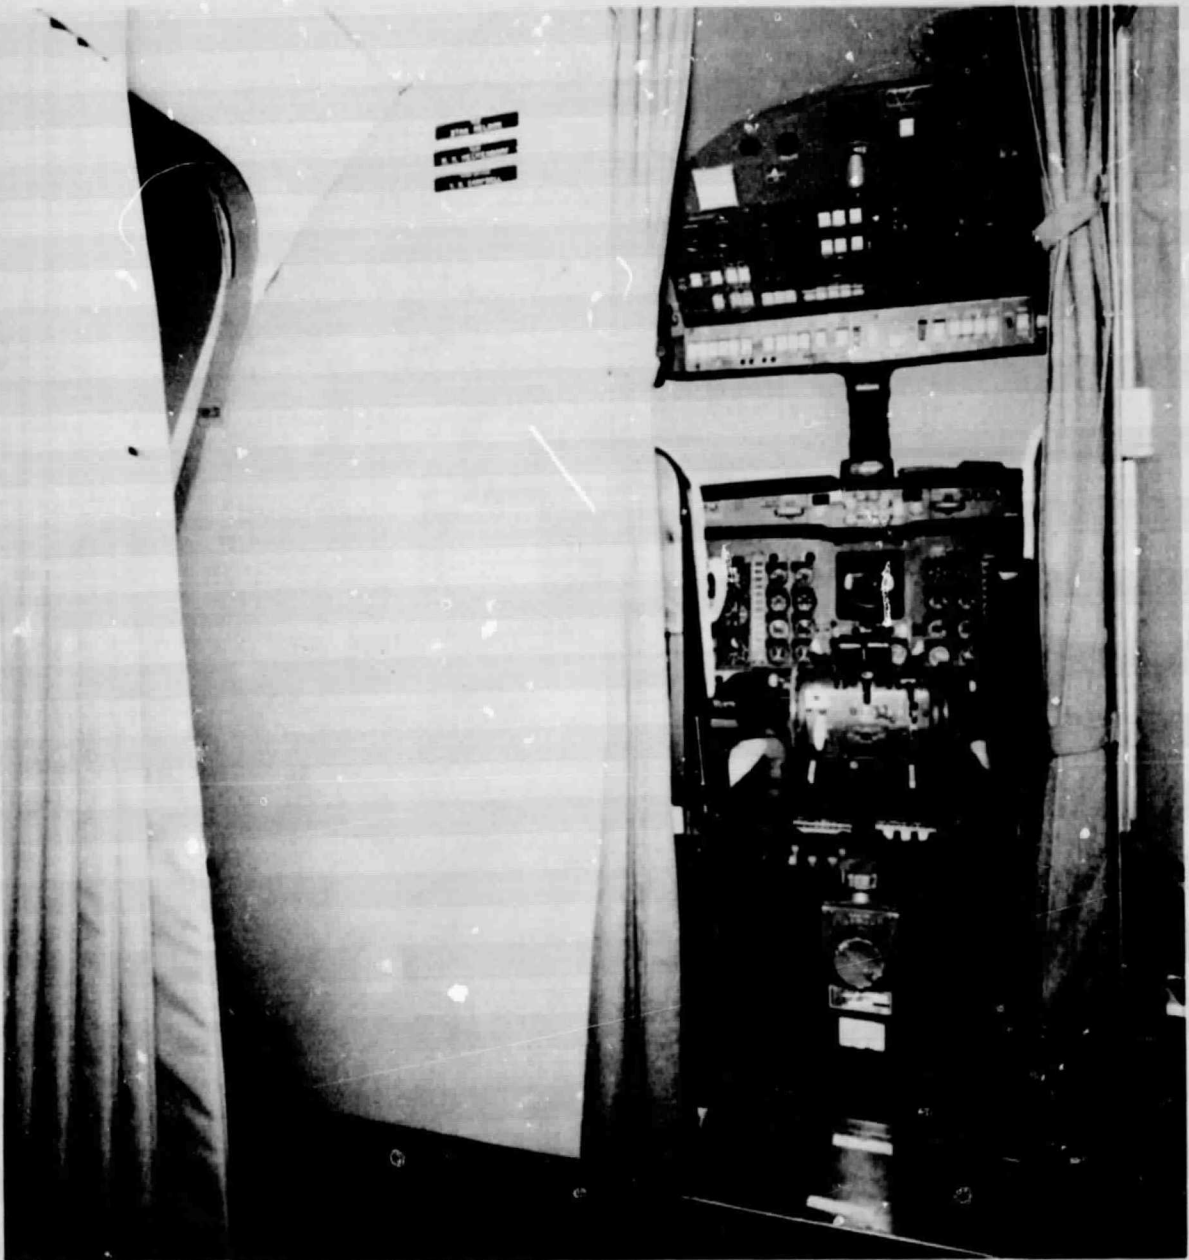
Figure 5.- Gulfstream 4 blue Fluorel-coated Nomex entrance wall covering and acoustical entrance drape.

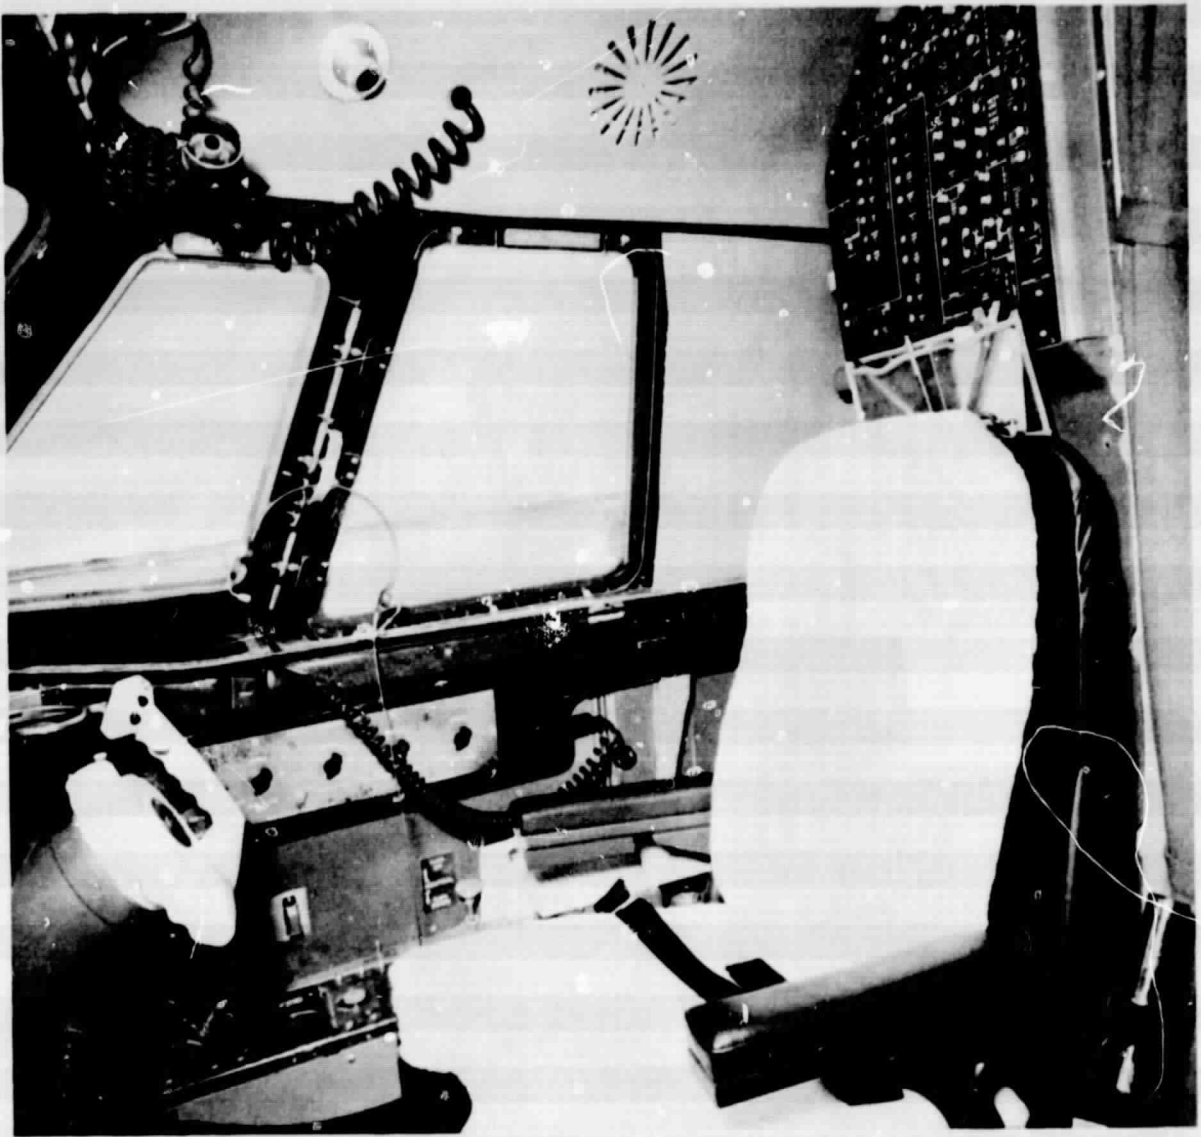
Figure 6.- Gulfstream 2 crew seat upholstery, fire-retardant lambswool and blue fire-retardant leather trim; cockpit drape, blue Flovan-treated wool.

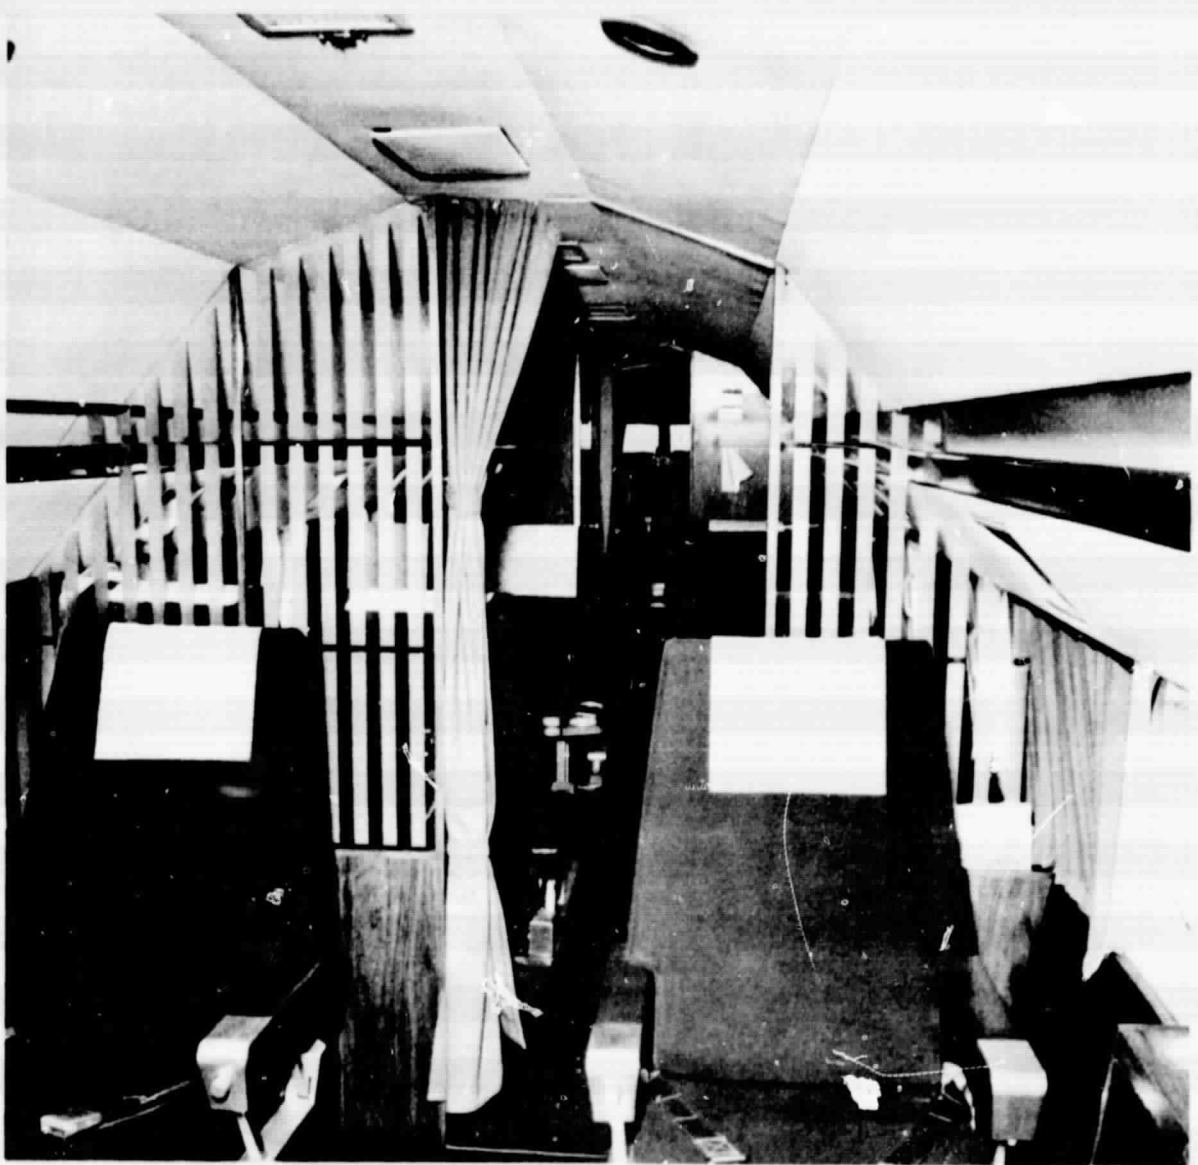
Figure 7.- Gulfstream 4 solid blue upholstery and blue 100-percent wool carpet.
